OPERATING EXPERIENCE WEEKLY SUMMARY

Office of Nuclear and Facility Safety

May 15 - May 21, 1998

Summary 98-20

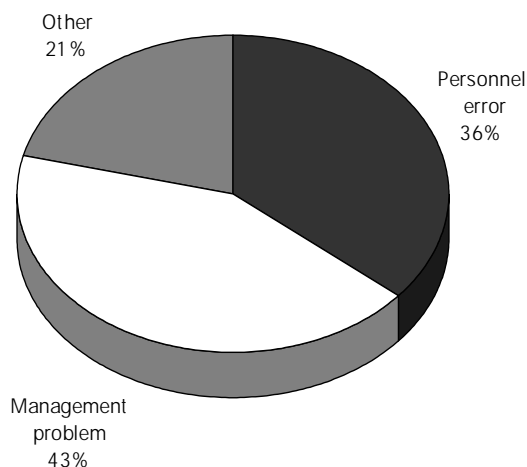
OEAF engineers searched the ORPS database for events with a nature of occurrence of procedure violation and the spread of contamination or personnel contamination from January 1990 to present and found 90 occurrences. Figure 4-1 shows the distribution of root causes for these events. A review of these occurrences shows that managers reported 43 percent of the root causes as management problems and 36 percent as personnel errors. Further review of the management problems shows that 44 percent were reported as inadequate administrative control, and 28 percent were reported as policy not adequately defined, disseminated, or enforced. Further review of the personnel errors shows that 69 percent were reported as inattention to detail. In addition, OEAF engineers reviewed all 90 occurrences and determined that managers attributed 13 percent of these events to laboratory personnel (professors, researchers, or experimenters).

Figure 4-1. Root Causes for Procedure Violations that Resulted in the Spread of Contamination¹
